DNA-TR-90-72-V3

**Exposure of Air Breathing Engines to Nuclear Dust  
Environment (U)  
Volume III—Performance Deterioration of a Second F100  
Turbofan Engine Upon Exposure to a Simulated Nuclear  
Dust Environment (U)**

Michael G. Dunn  
Calspan Corporation  
P.O. Box 400  
Buffalo, NY 14225

January 1991

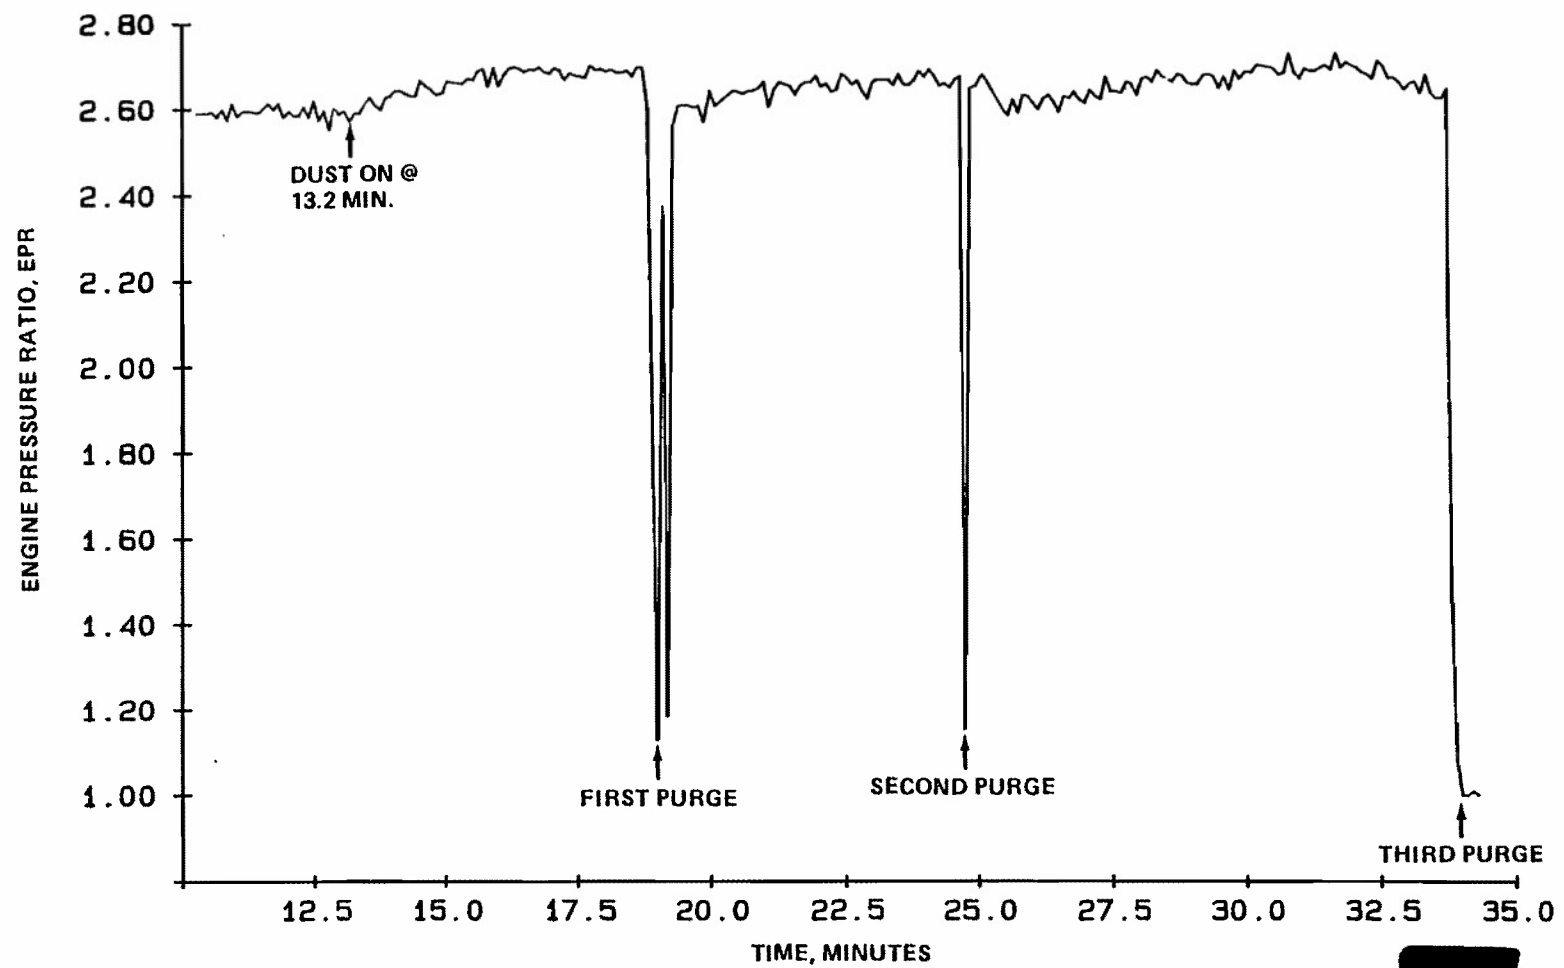
Figure 1. (U) Time history of engine pressure ratio (EPR).

[REDACTED] Probably the second most easily observed indicator of the presence of the dust cloud at these high power settings is the increase in engine pressure ratio (EPR,  $P_{T2}/P_{T6}$ ). Figure 1 is a time history of the engine pressure ratio. Before the dust was turned on, the throttle was set by the operator so that the engine was operating at an EPR of about 2.60. The dust was turned on at 13.2 minutes and an immediate increase in EPR is observed. The EPR increased steadily during the first four minutes of dust exposure at a rate of 0.3 per minute. After about six minutes of dust exposure, the burner pressure had increased to such a high value that it was prudent to attempt to clear what was thought to be deposited material from the engine. Therefore, at 19.3 minutes the throttle was rapidly cycled as can be seen from the data record of Figure 1. At the conclusion of the throttle excursions, the EPR was set by the operator to a value very near the initial value of 2.60. The flow of dust was not turned off during the entire test matrix. During the second period of dust ingestion, the EPR again increased steadily but at a slower rate (0.16 per minute) than during the first dust exposure period. At about 24.8 minutes, it again became necessary to clear the engine of deposited material as can be seen from Figure 1. Once again, the EPR was returned by the operator to near the pre-dust exposure value of 2.60. During the ensuing exposure period, the EPR increased steadily, until about 32.5 minutes. At 32.5 minutes, it became clear to the operators that the control system was taking over control of the engine and that it would again be prudent to clear the deposited material. Therefore, a third clearing attempt was initiated. We were unable to recover control

it appeared that the engine had been successfully cleared without event. However, during the second exposure, the ratio again increased rapidly as it had done during the initial exposure. The engine was purged a second time, but the excursion in the pressure ratio was not as great as during the first purge. It is possible that the peak and valley may have been missed due to the five second sampling frequency of the data. The second purge was not as effective as the first in that the ratio did not quite return to the pre-dust exposure value of 0.99. The pressure ratio came sufficiently close to the pre-dust value that we were encouraged that the engine had been cleared. During both the first and second purges, a shower of material could be seen exiting the tail pipe. After the second purge, the ratio climbed again in a series of steps of about one-half minute in duration to a peak of 1.07. Near the end of the third exposure interval, the ratio levelled off and then fell to 1.05 just prior to the third purge. This behavior near the end of the third exposure period is consistent with the EPR data shown on Figure 1.

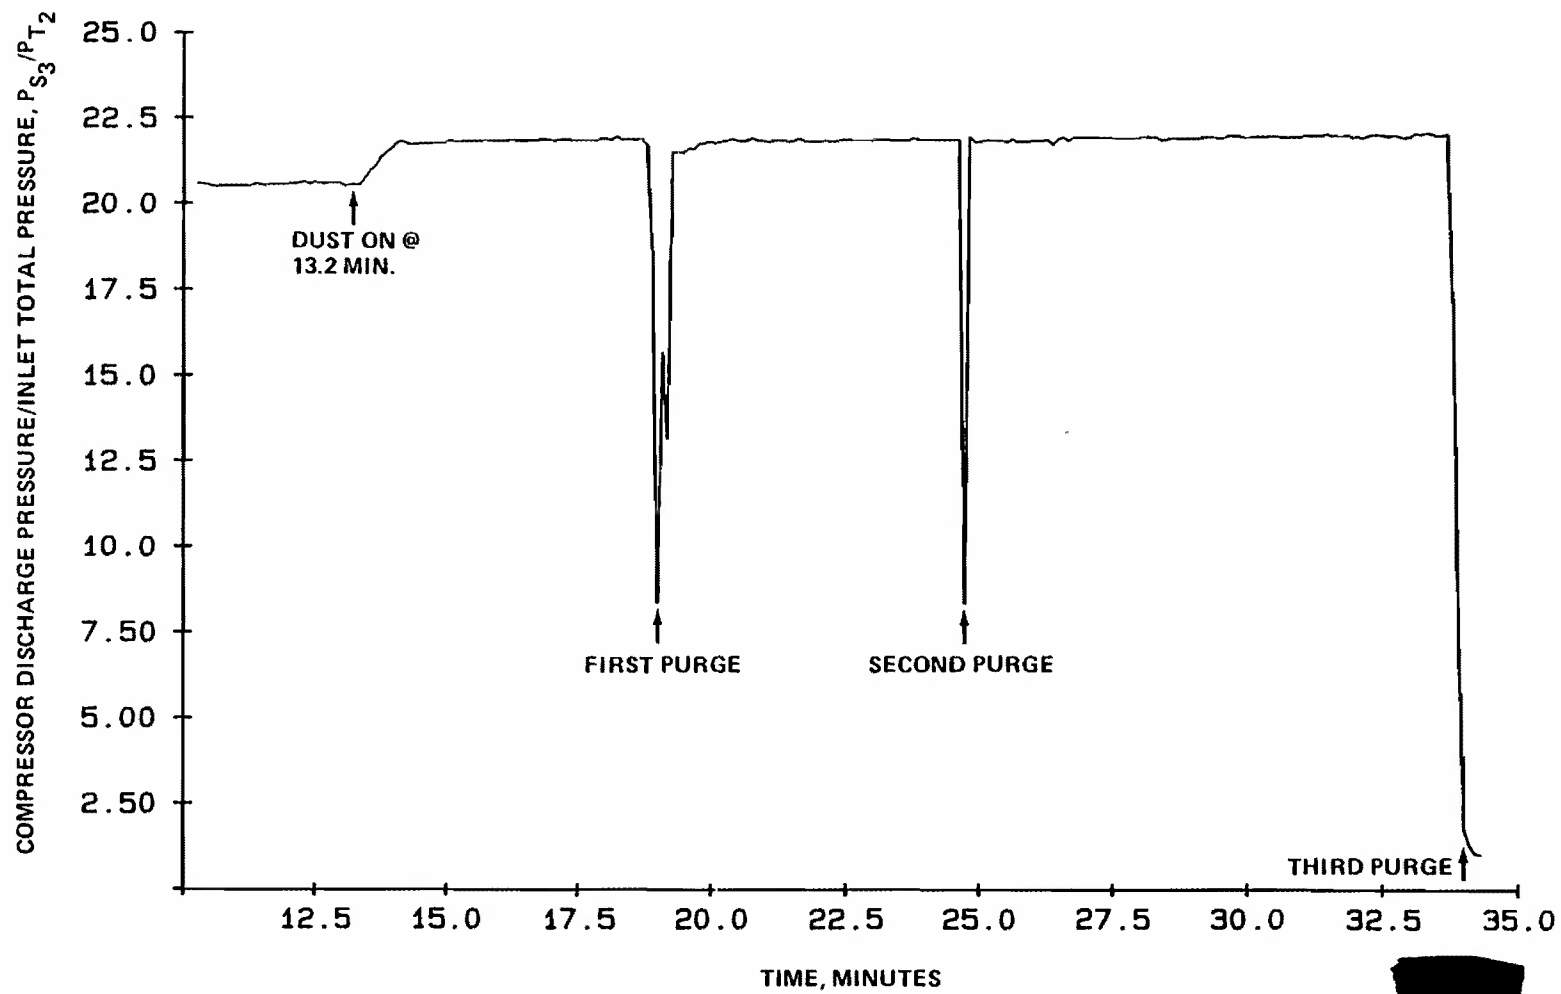
Figure 2. (U) Time history of overall compressor pressure ratio.

[REDACTED] Figure 2 presents the overall compressor pressure ratio ( $P_{S_3}/P_{T_2}$ ) as a function of time. Prior to turning on the dust, the engine was operating at a value of about 20.5. Relatively soon after the dust was turned on, the compressor discharge static pressure ( $P_{S_3}$ ) began to increase rapidly with the ratio reaching a value of about 21.8 in less than a minute. The engine was then purged at 19.3 minutes as described in the preceding paragraph. When the throttle was adjusted to give an EPR of 2.60, the compressor ratio did not return to its pre-dust exposure value. However, it did return part way, followed by a rapid increase to the value at which the machine was operating near the end of the first exposure period. The throttle was again cycled at about 24.8 minutes and the EPR was returned to 2.60. This second throttle cycle had essentially no influences on the overall compressor pressure ratio at which the machine was operating as can be seen from Figure 2.

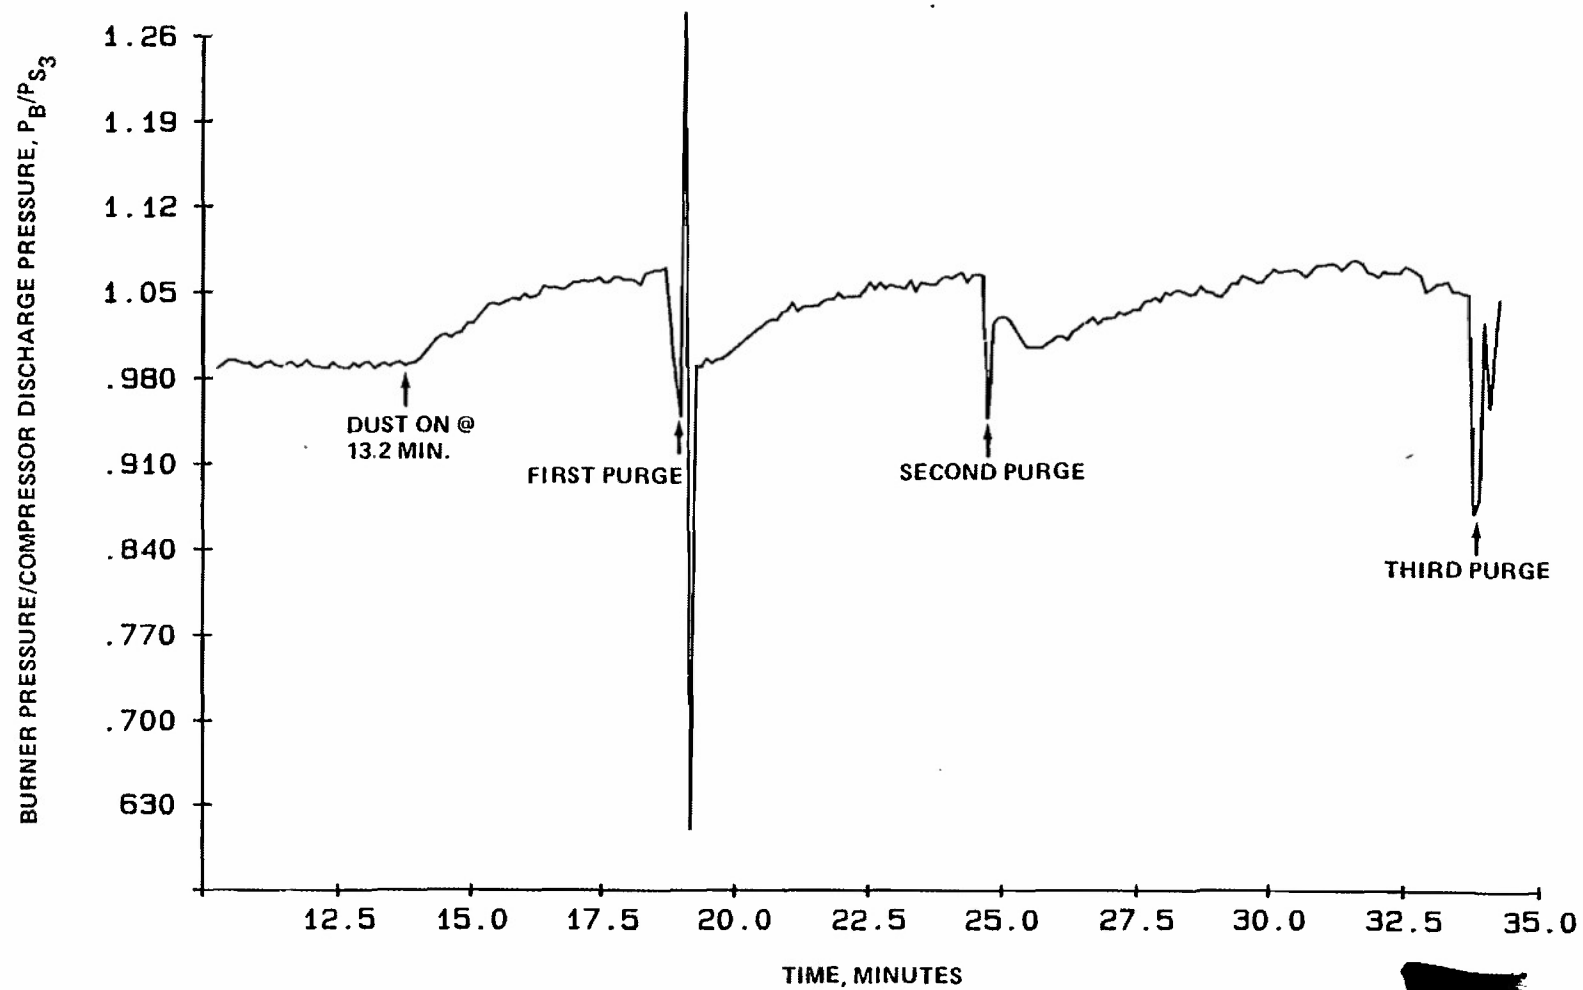
Figure 3. (U) Time history of the ratio of burner pressure to compressor discharge pressure.

[REDACTED] Figure 3 presents the burner static pressure ( $P_b$ ) divided by the compressor discharge static pressure ( $P_{S_3}$ ) and represents one of the more interesting time histories that has been extracted from the data. The compressor discharge static pressure ( $P_{S_3}$ ) divided by the inlet total pressure ( $P_{T_2}$ ) was just presented in Figure 2. The inlet total pressure is essentially constant during these experiments. The inlet total pressure was measured as was the weight flow of air which was also nearly constant as demonstrated in Figure 4. Therefore, the activity shown on Figure 2 is the result of increasing compressor discharge pressure and is not due to decreasing inlet total pressure. The ratio shown in Figure 3 is a figure of merit of the downstream loading on the compressor. Figure 3 illustrates that soon after the dust is turned on, the burner pressure begins to increase rapidly. It is quite possible for the burner pressure to become higher than the compressor discharge pressure without surging the engine because both of these quantities are static pressures and the flow velocities in the combustor are far lower than in the compressor exit nozzle. If burner pressure were taken to be nearly the gas stagnation pressure of the compressor, then the compressor exit Mach number would be 0.31 and such a number is certainly possible. During acceleration in the first purge shown on Figure 3, the pressure ratio reached 1.28 for a brief time without any surge or stall and then dropped to 0.61 for a brief period, followed by stabilization at the pre-dust exposure value of 0.99. This result was encouraging and

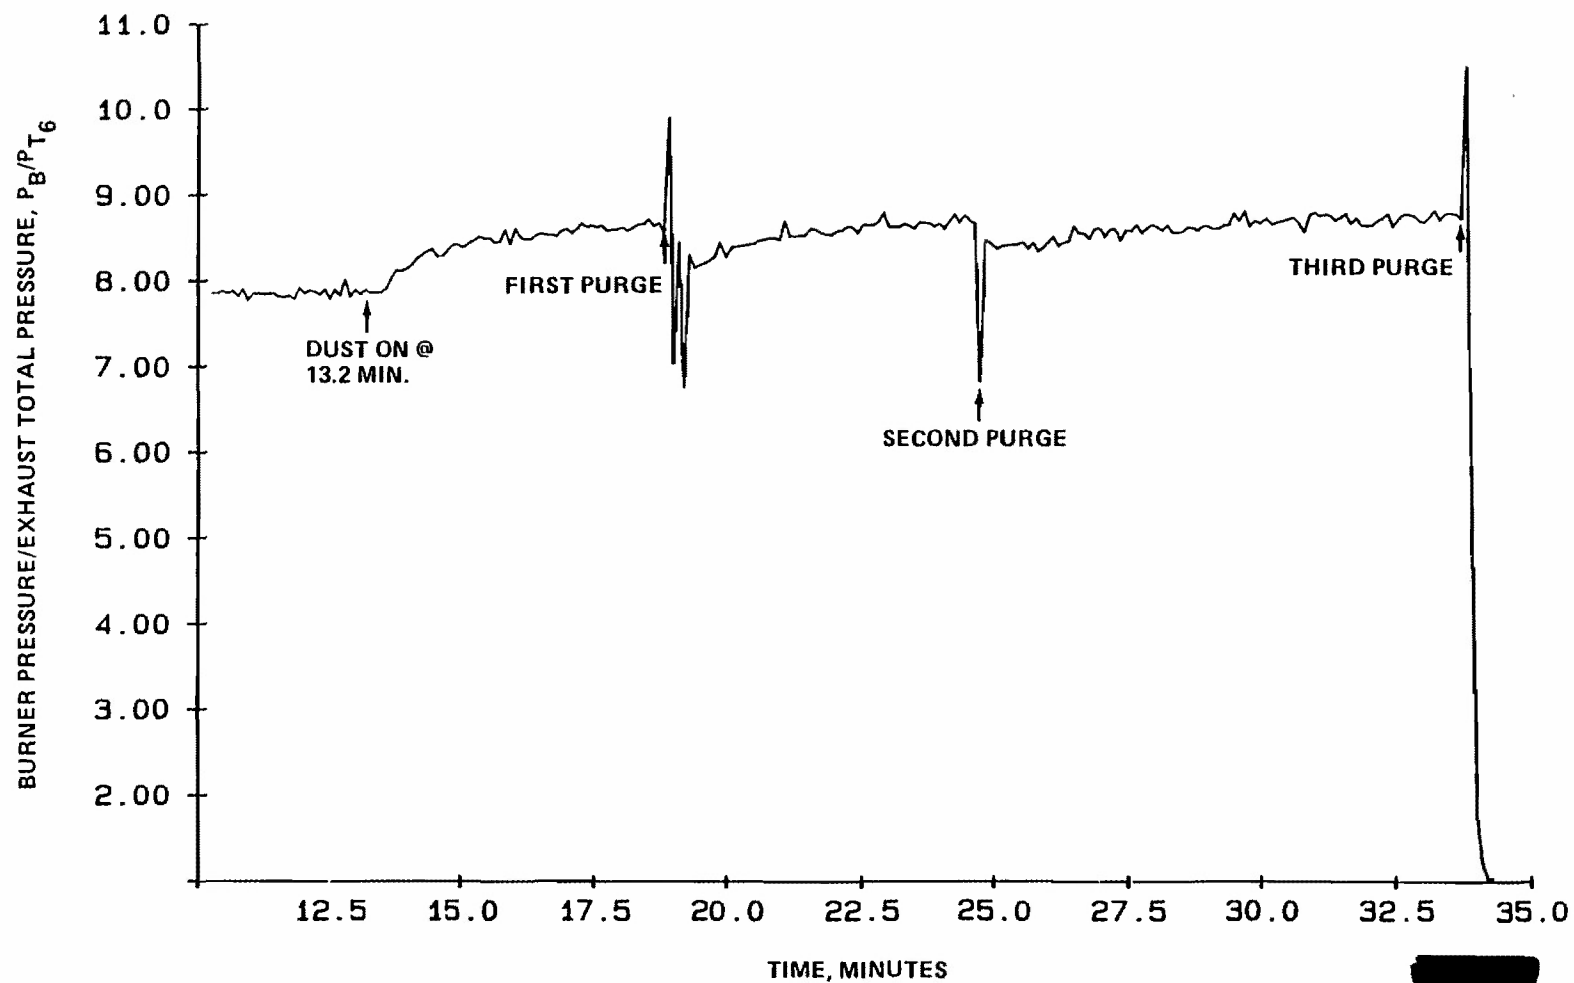
Figure 4. (U) Time history of the ratio of burner pressure to turbine exhaust pressure.

(U) Figure 4 presents the time history of the burner pressure normalized by the turbine exhaust pressure. The result shown on this plot is very similar to that shown on Figure 3 which was the burner pressure normalized by the compressor discharge pressure. These two figures suggest that the aerodynamic trends observed in the hot section region carry on through the exhaust system, which is as would have been anticipated.

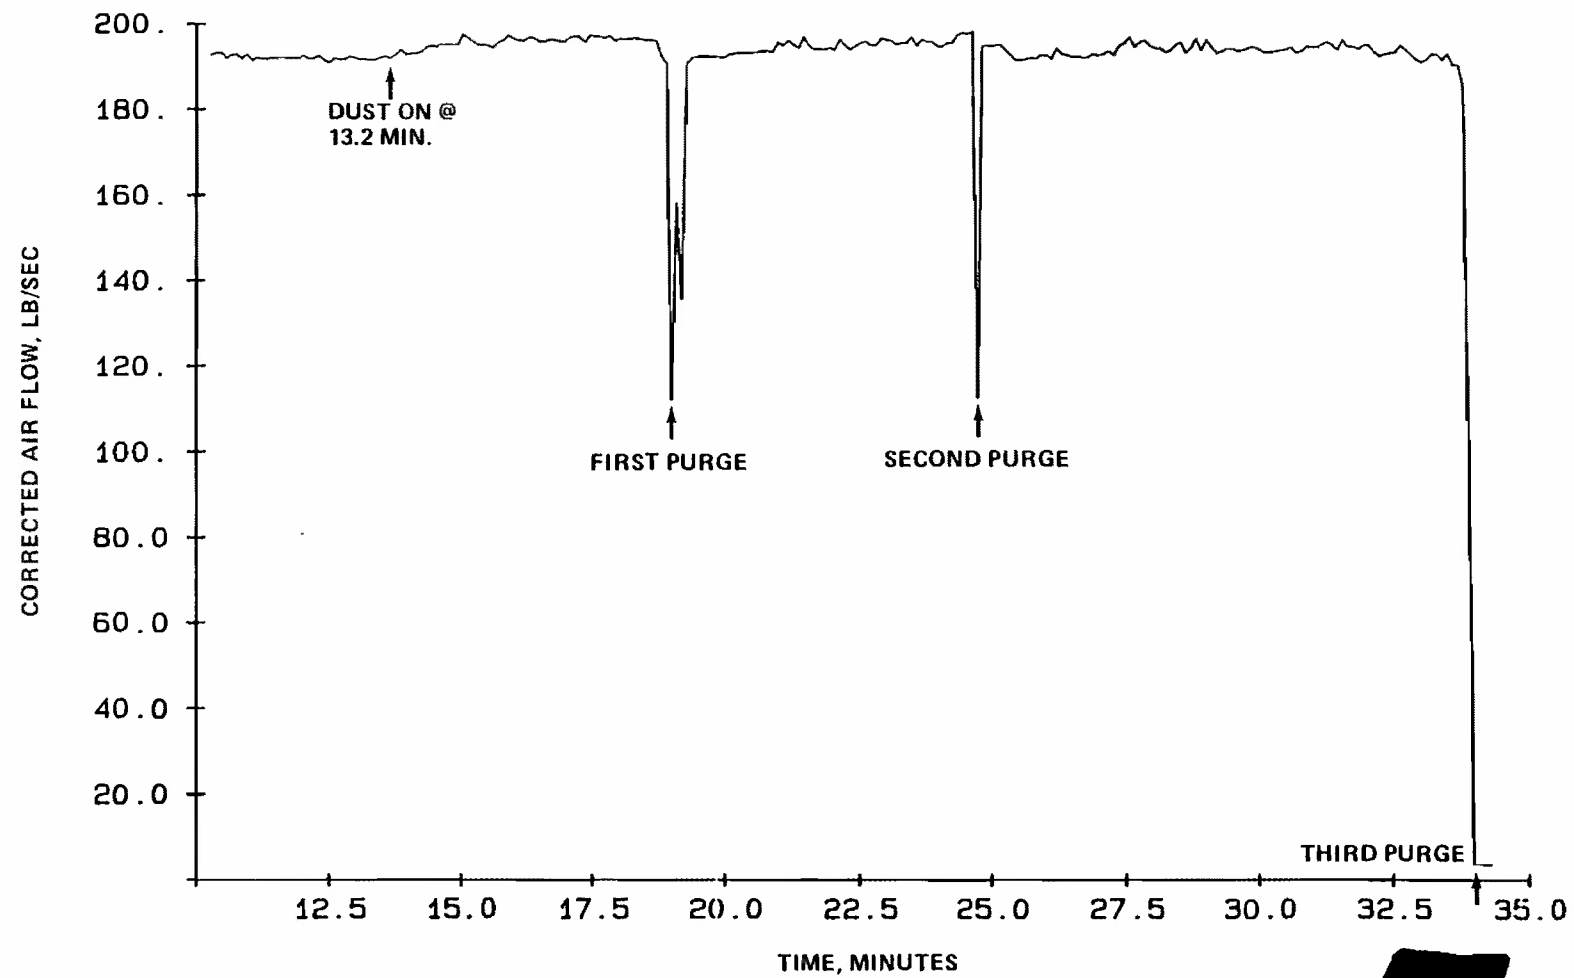
Figure 5. (U) Time history of corrected weight flow of air.

[REDACTED] Figure 5 presents the time history of the corrected weight flow of air through the machine. The time at which the dust is turned on is marked on this figure as are the times of the three purges. During the first dust exposure period, there is a slight increase in air flow with increasing time. After both the first and second purges, the weight flow returned to the pre-dust exposure level. Also note that during the first minute or minute and one-half after the first and second purges, the character of the trace is very quiet. However, with increasing exposure time, activity on the data record suggests changing conditions within the engine.

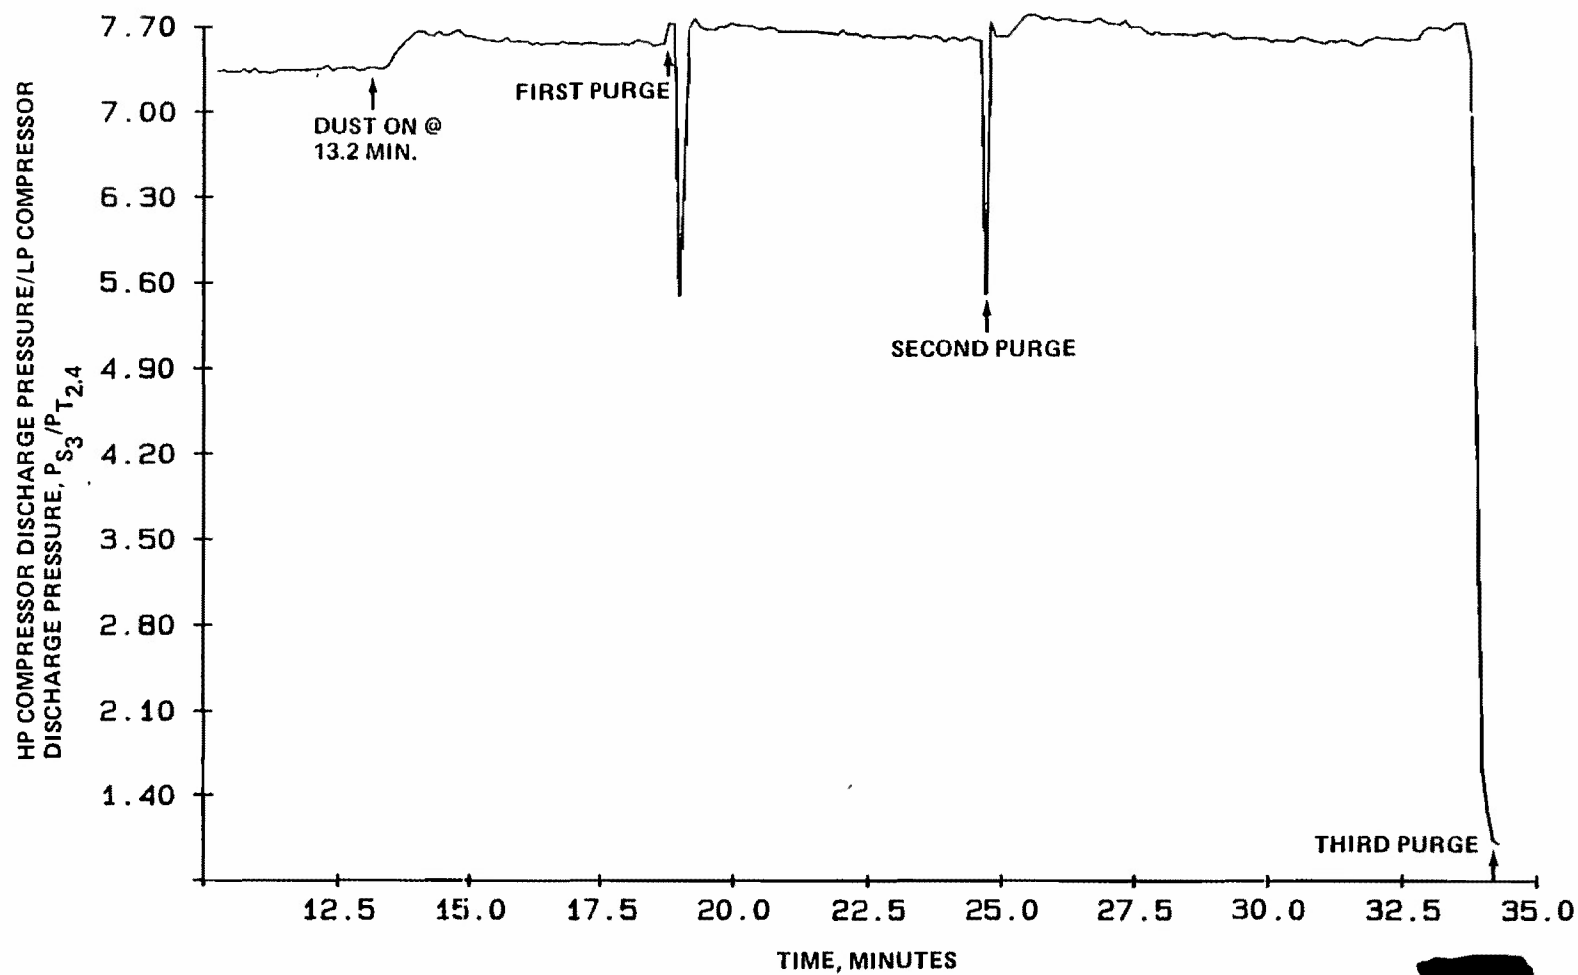
Figure 6. (U) Time history of high-pressure compressor pressure ratio.

[REDACTED] Figures 6 and 7 present the components of the compression system that make up the result presented in Figure 2. Figure 6 represents the compression of the high pressure compressor and Figure 7 represents the compression of the low pressure compressor. The high-pressure compressor pressure ratio increased by about 0.33 during the first one-half minute of dust exposure. The pressure ratio declined at a rate of

about 0.02 per minute until the first purge. After the first purge, the pressure ratio did not return to the pre-dust value but it did return to the peak value that occurred about one-half minute after initiation of the dust flow. Following the second purge, the compression ratio increased to a value higher than the initial peak followed by a steady decline until about thirty-two minutes at which time the trend turned around and the pressure ratio began to increase in a series of steps each about one minute apart. The low-pressure compressor pressure ratio shown in Figure 7 has a different behavior than that just described for the high-pressure compressor. The pressure ratio for the low-pressure compressor increased steadily until the first purge. After the first purge, the pressure ratio returned to near the pre-dust exposure value and then began a steady increase until the second purge. After the second purge, the pressure ratio again returned to the pre-dust exposure value. Near the thirty-two minute point of the third exposure, the pressure ratio began to fall as shown. With the exception of the initial one-half minute of dust exposure, the trend of the low-pressure compressor data during dust exposure was opposite to that of the high-pressure compressor.

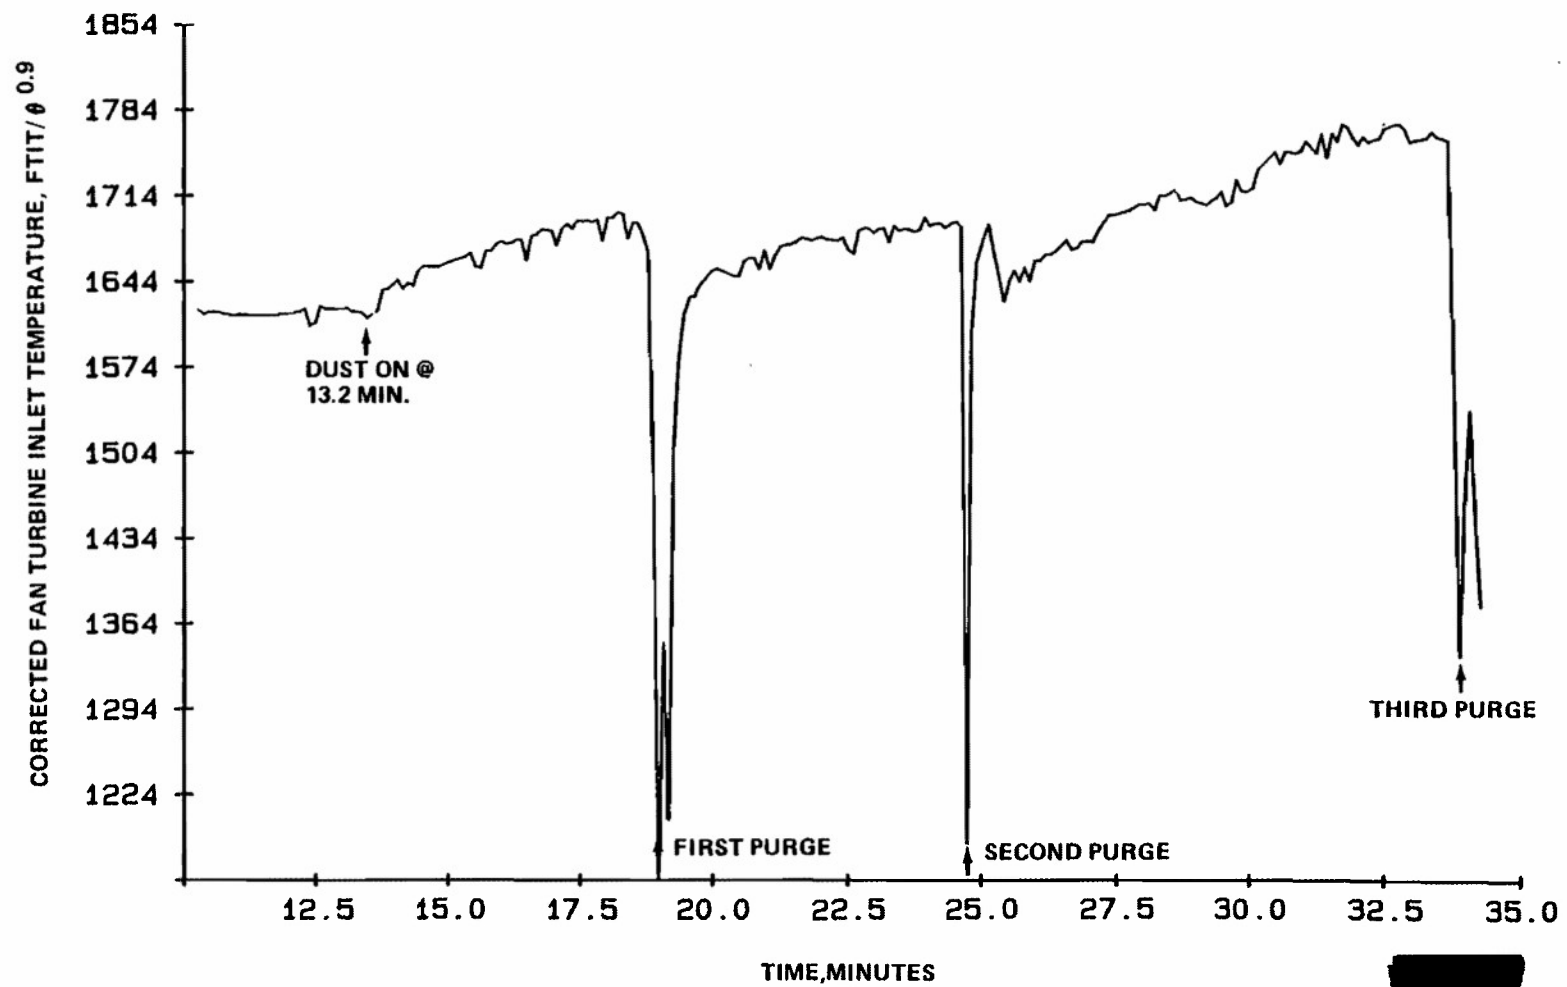
Figure 8. (U) Time history of corrected fan turbine inlet temperature.

[REDACTED] Figure 8 presents the corrected fan turbine inlet temperature (FTIT) time history. The FTIT responds very quickly to the presence of dust as can be seen from the results presented in Figure 8. The average corrected FTIT increased by 50°F in the first minute of dust exposure. It continued to increase to a peak of nearly 1700°F (up 80°F from the starting value) until just before the first purge. The first purge reduced the corrected FTIT by 60°F. However, after this purge, the FTIT continued to increase by about 6°F per minute. The second purge did little to retard this rate of rise and the FTIT increased at a rate of 14°F per minute for the five minutes following the second purge. Near the end of the third exposure period, the corrected FTIT leveled off at a value near 1760°F as can be seen from Figure 8.

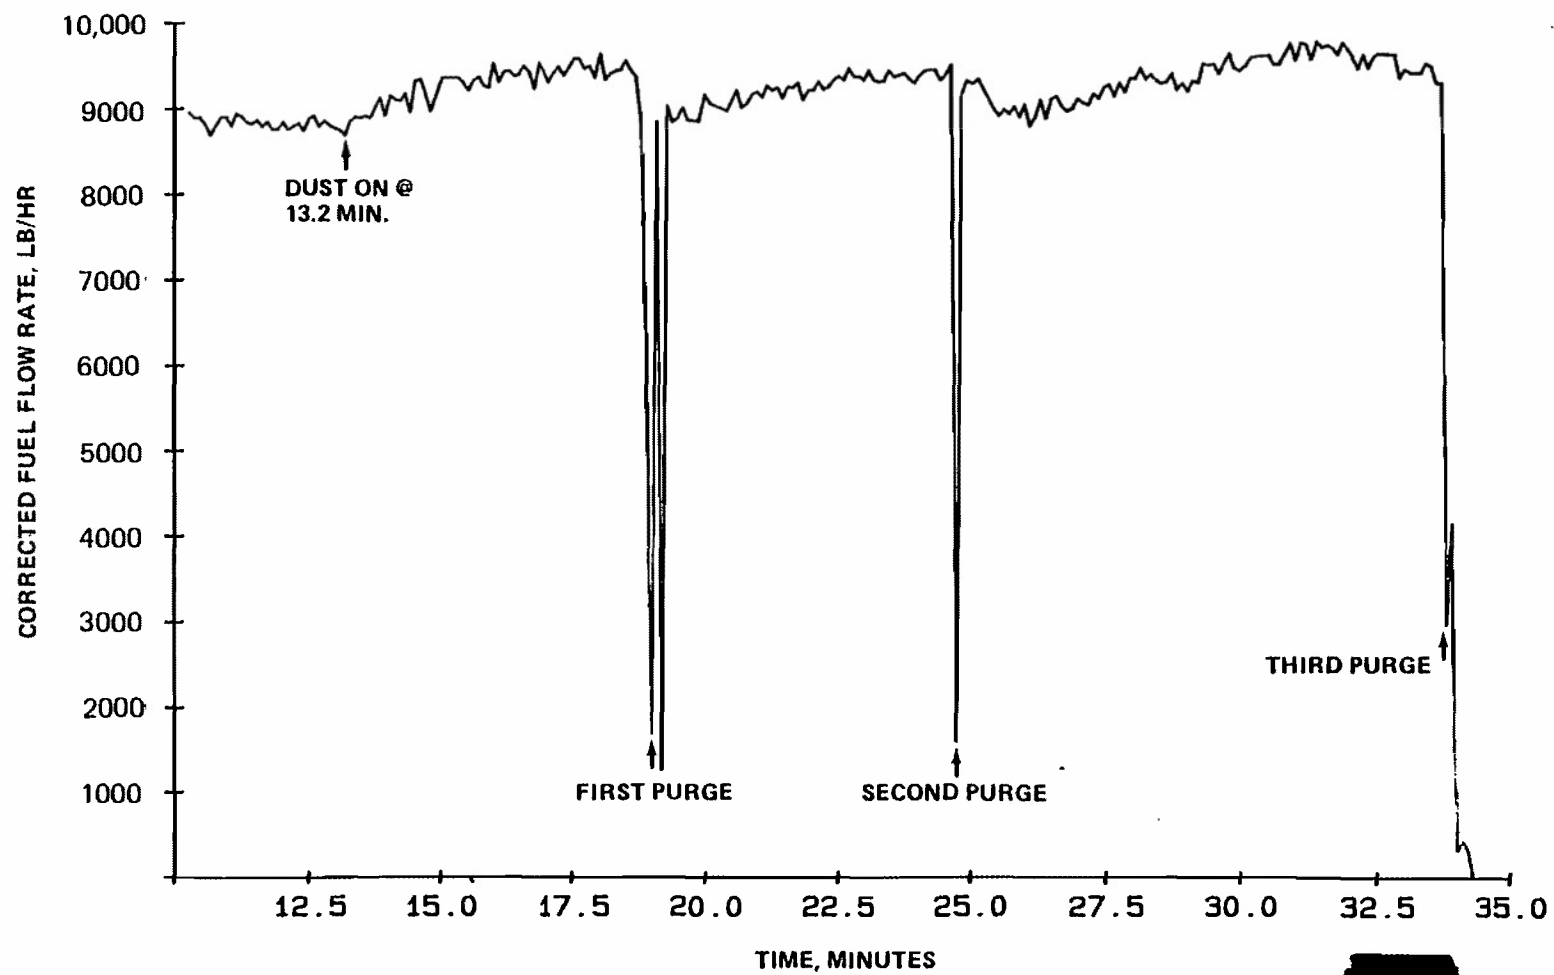
Figure 9. (U) Time history of corrected fuel flow rate.

[REDACTED] Figure 9 presents the time history of corrected fuel flow rate. Very soon after the dust is turned on, the fuel flow rate begins to increase from a pre-dust exposure value in the vicinity of 8800 lbs/hr to a value of about 9500 lbs/hr six minutes later and just before the first purge. Immediately after the first purge, the fuel flow returns to a value that is near the pre-dust exposure value. However, with continued exposure, the flow rate continues to climb at a rate of about 100 lbs/hr for each minute of exposure. After the second purge, the flow rate again returned to the pre-dust exposure value, but once again continued to climb until about two minutes prior to the

third purge at which time the flow rate began to decrease. This decrease is a correction caused by the unified engine control.

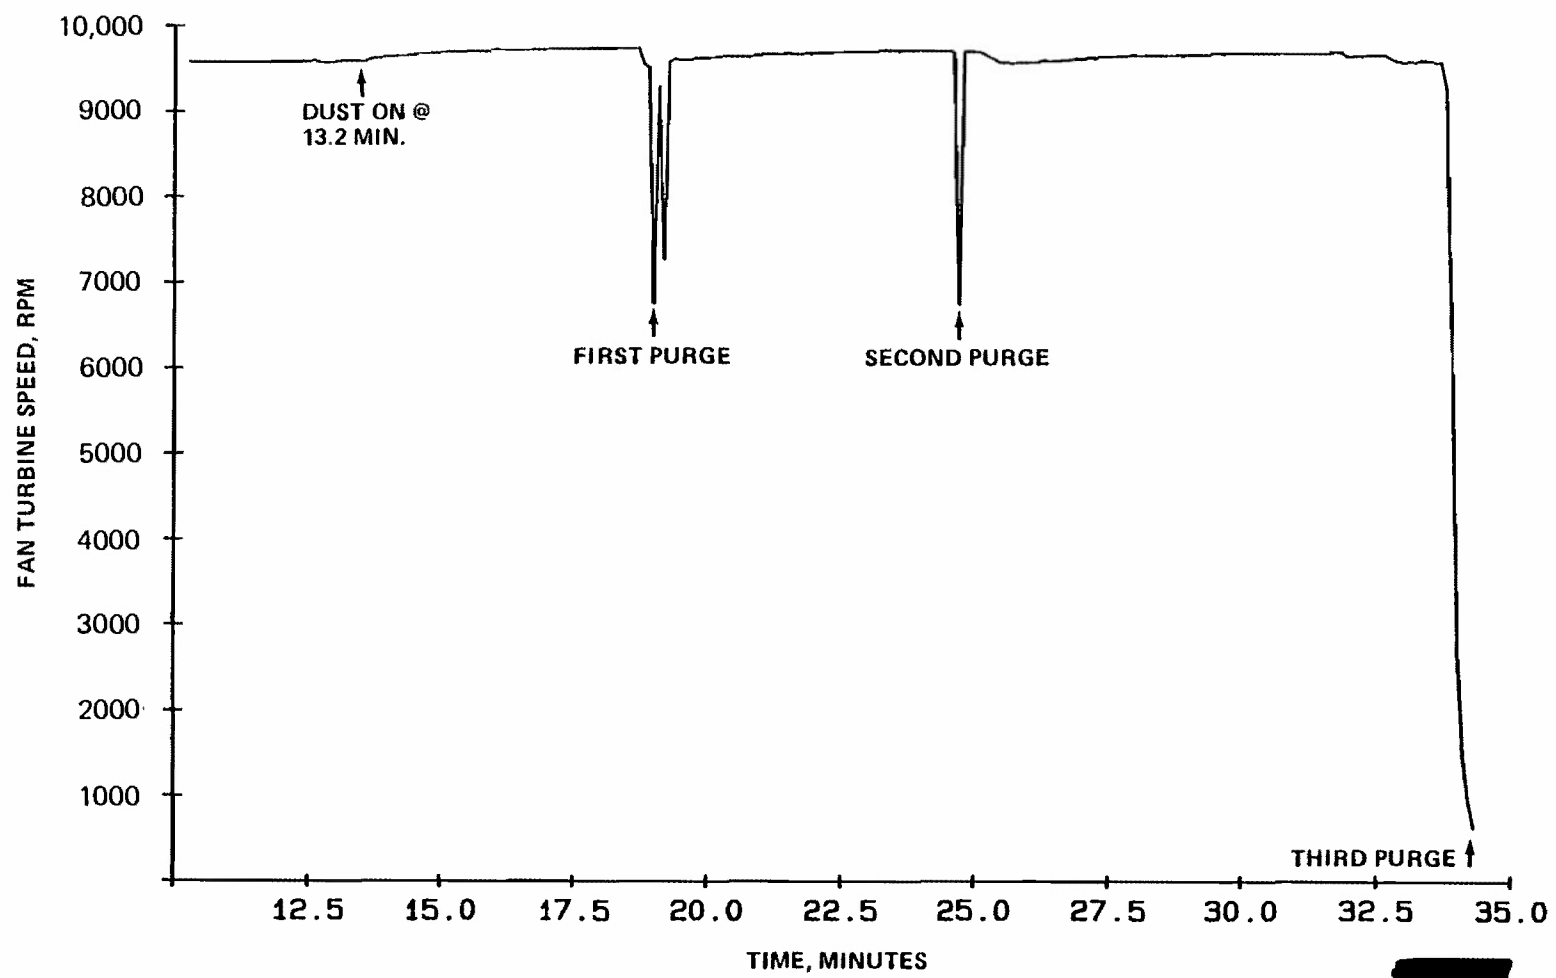
Figure 10. (U) Time history of fan turbine speed.

[REDACTED] Figure 10 presents the time history of the fan turbine speed. One of the main functions of the control system is to protect the fan from overspeeding. As soon as the dust is turned on, a gradual increase in fan speed can be observed over the initial six minutes of dust exposure. Immediately after the first purge, the fan speed returned to the pre-dust exposure value. During the second six minutes of dust exposure, the fan speed held very constant. After the second purge, the fan speed again returned to the pre-dust value and remained constant for a very brief period of time. During the third exposure period, the control system became more involved and the fan speed decreased from the pre-dust value slowly from about 26 minutes until about 32 minutes, but then decreased in stepwise fashion over the final 2.5 to 3 minutes.

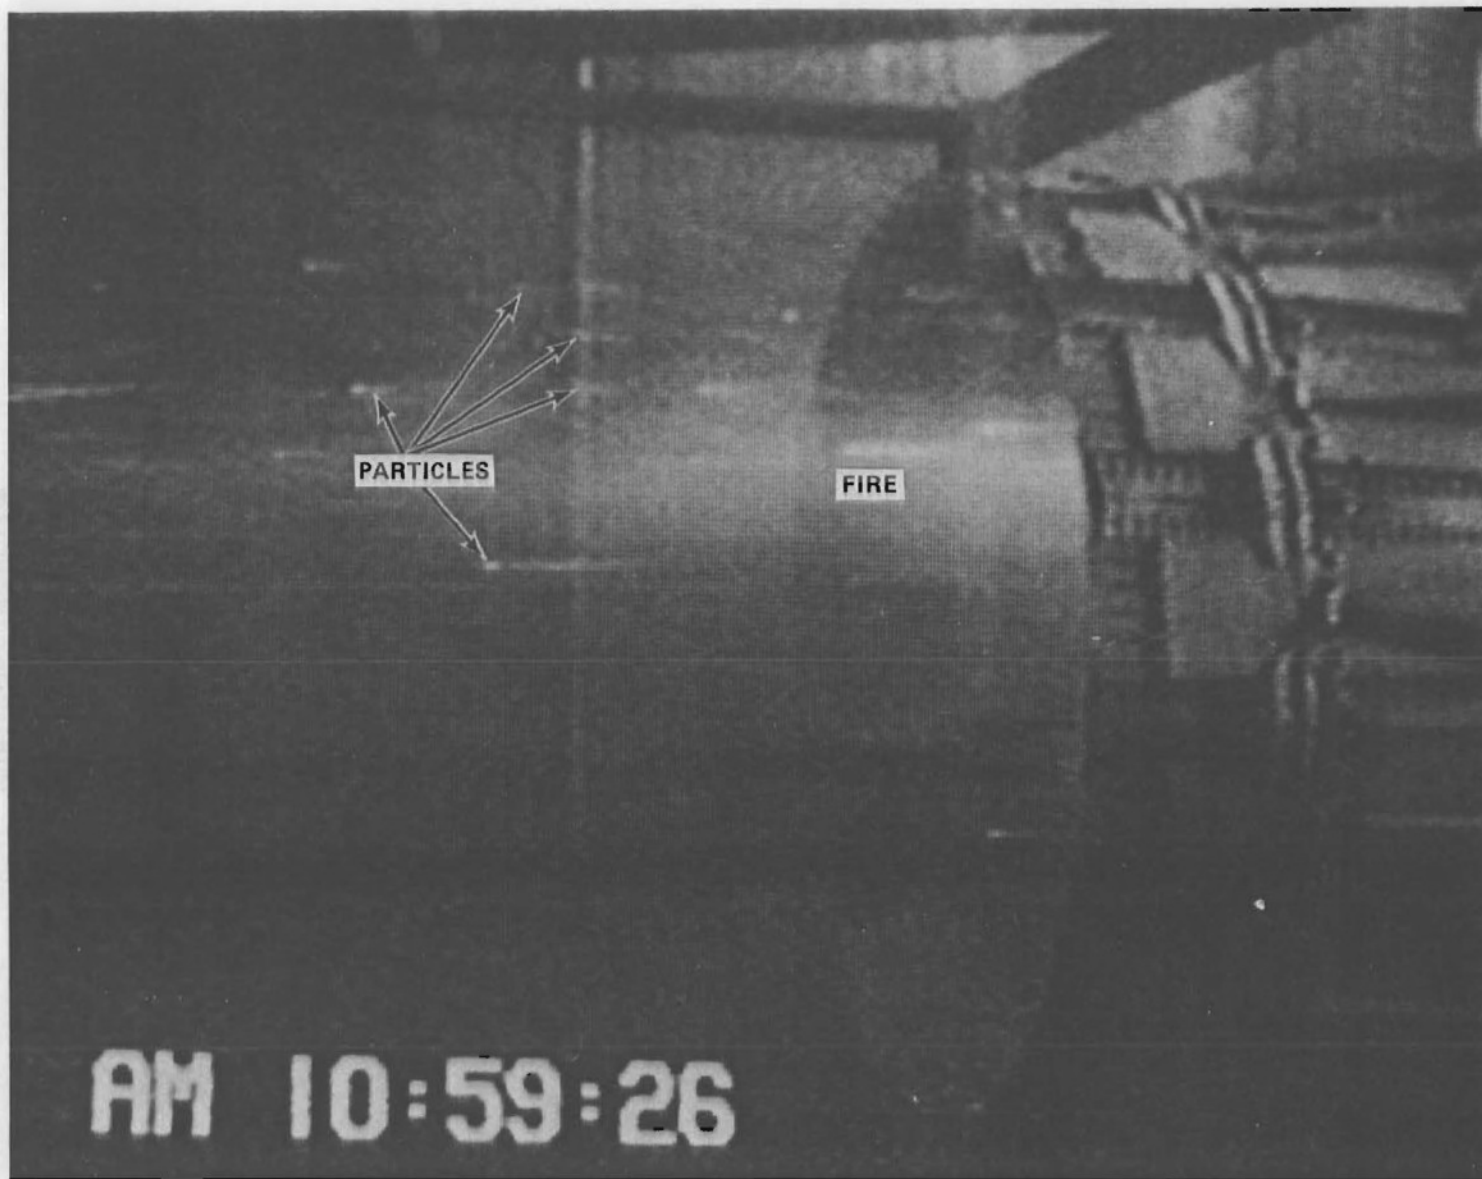
Figure 12. (U) Photograph of particles exiting machine during surge event.

obliterated by the brightness of the flame. On this photograph, one can easily see a few glowing particles exiting the tailpipe of the engine. Figure 13 is a third photograph taken during the surge events that again illustrates many glowing particles and a reduced amount of flame exiting the tailpipe. After inspection of the engine components during the teardown, it is felt that the glowing particles seen in these photographs are pieces of the glassified material that have been purged from the hot section of the machine and they are probably not pieces of metal removed from the machine.

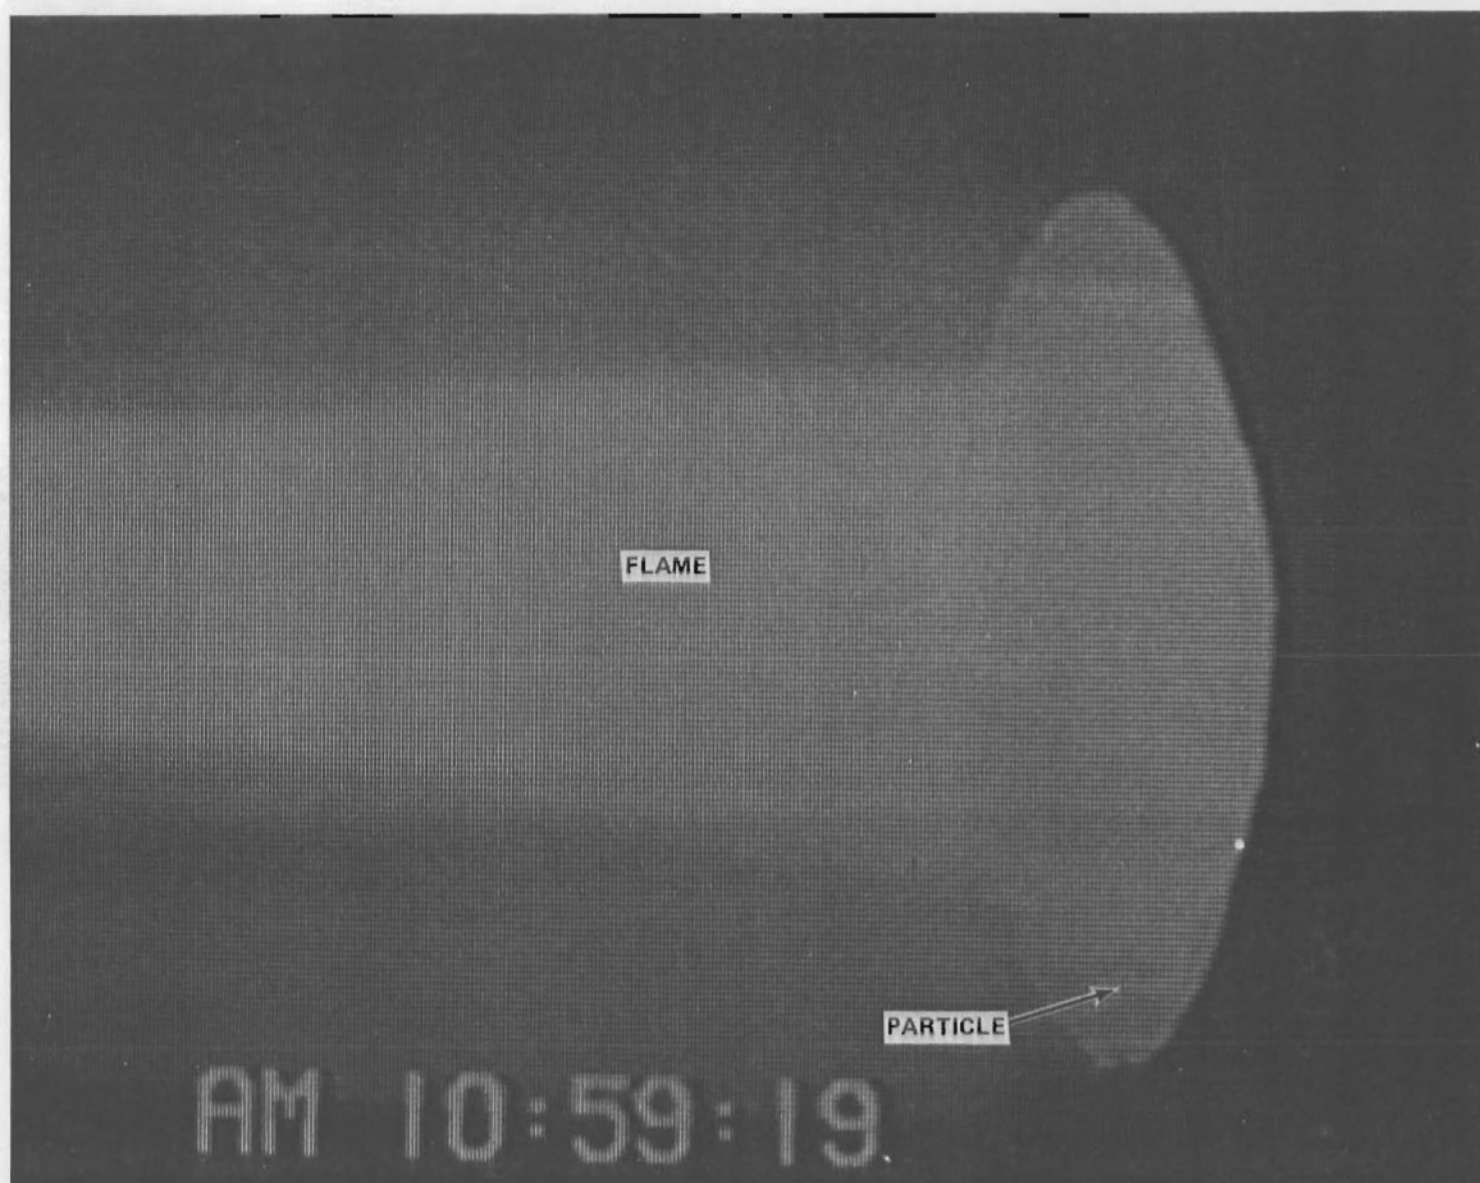
Figure 13. (U) Photograph of particles and flame exiting tailpipe during surge event.
